# CORROSION OF HIGHWAY BRIDGES IN VIRGINIA

Junyi Meng, Ph.D., P.E., Assistant State Structure and Bridge Engineer

December 17, 2018

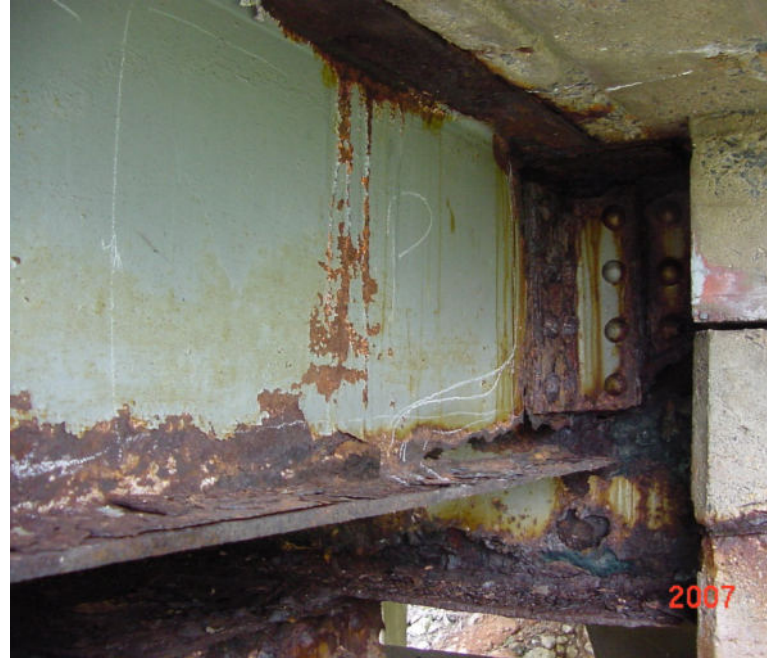
Steel Beam

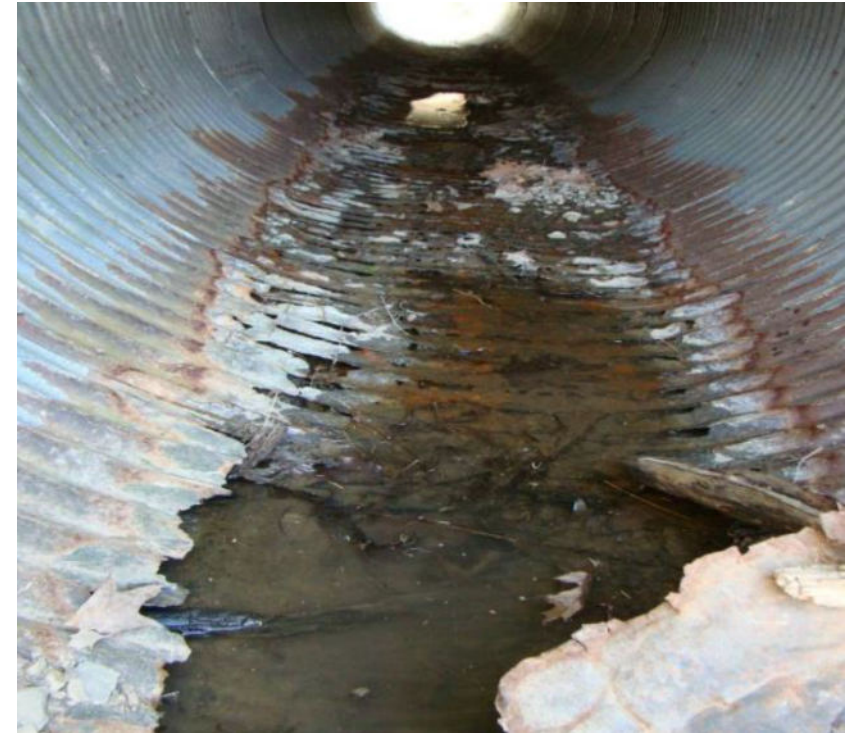
Steel Pipe Culvert

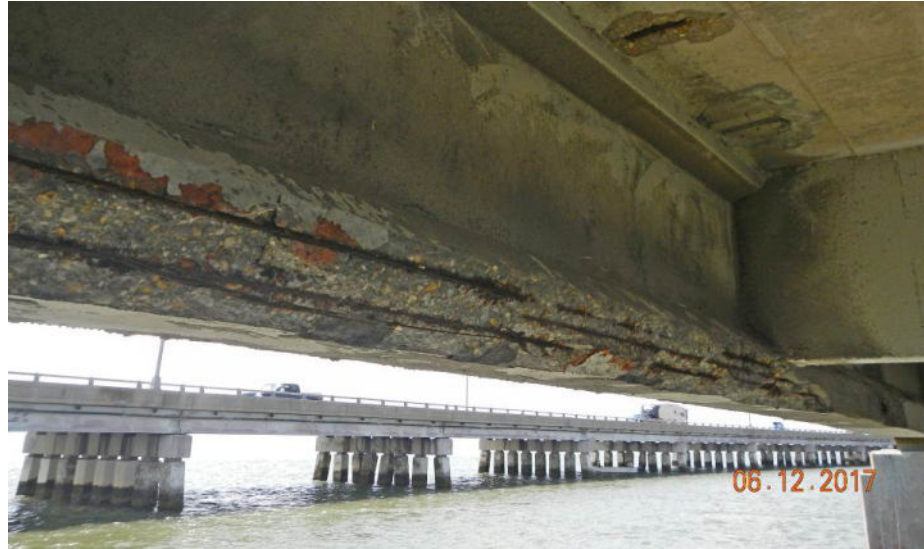
Concrete Beam

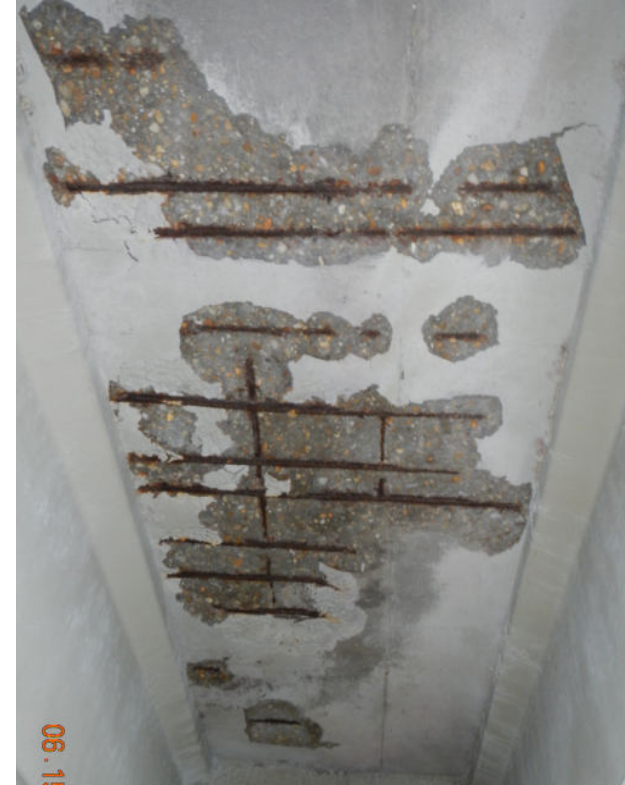
Bottom of Deck

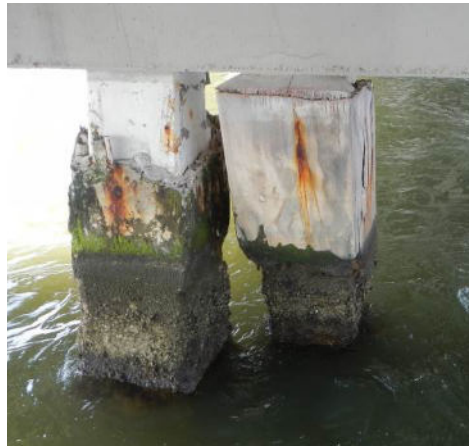
Pile Bents

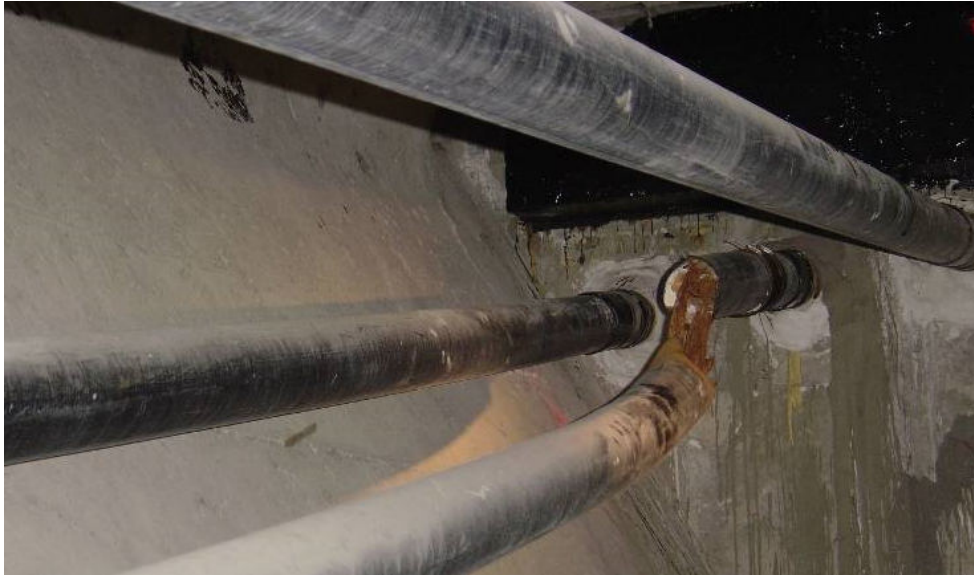
**CORROSION IS A  
LEADING CAUSE OF  
BRIDGE DETERIORATION**

Steel Cable

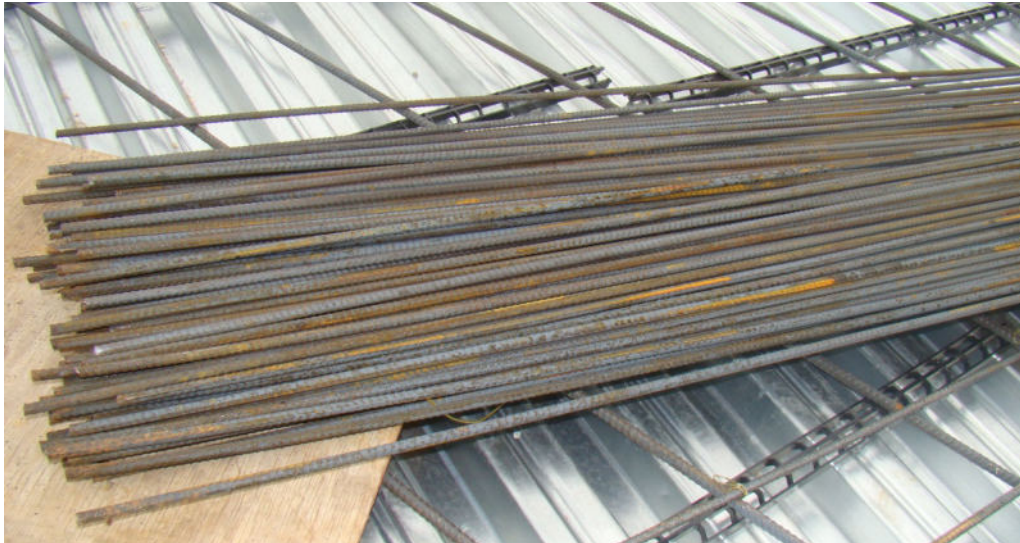
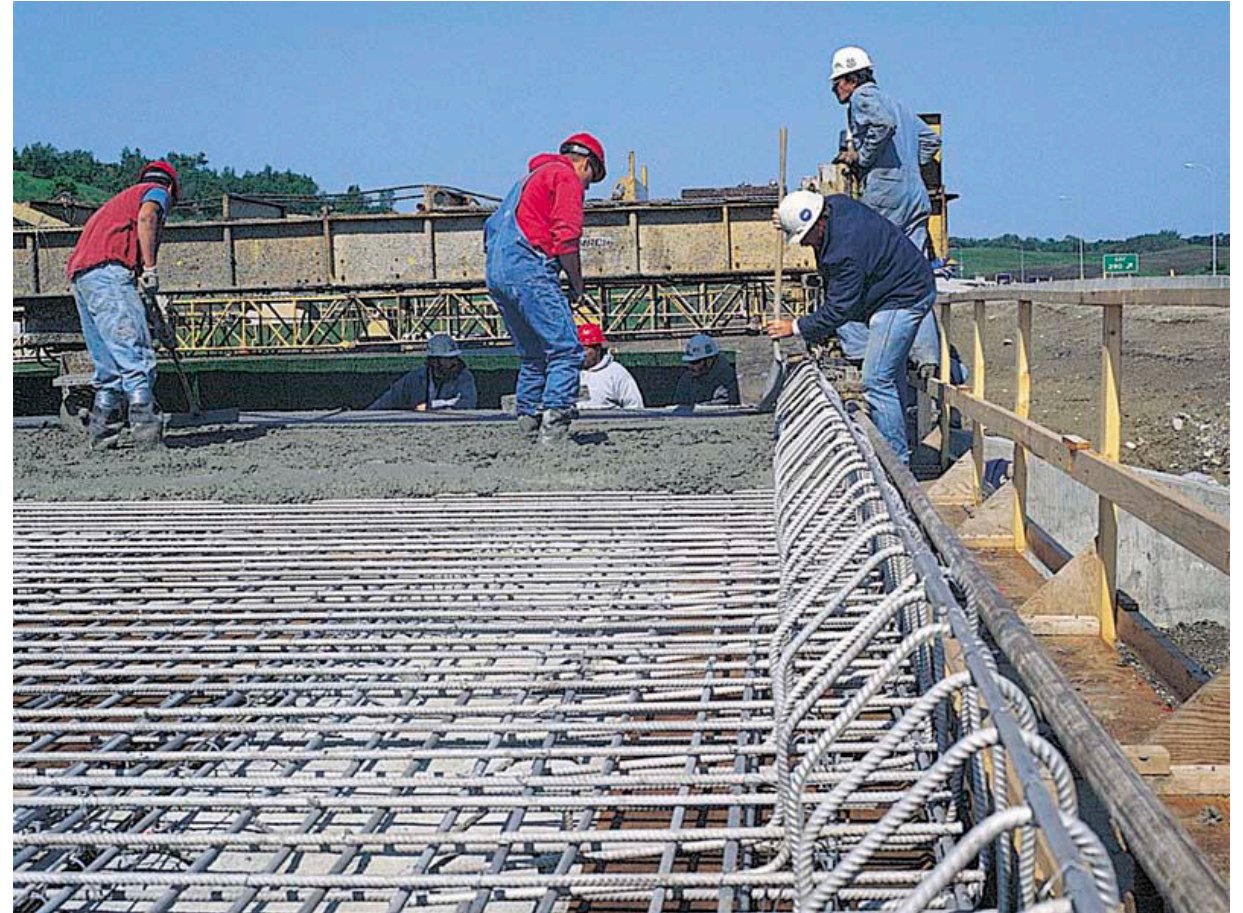
# Corrosion Resistant Reinforcing Steel

- Low Carbon and Chromium
- Stainless Steel

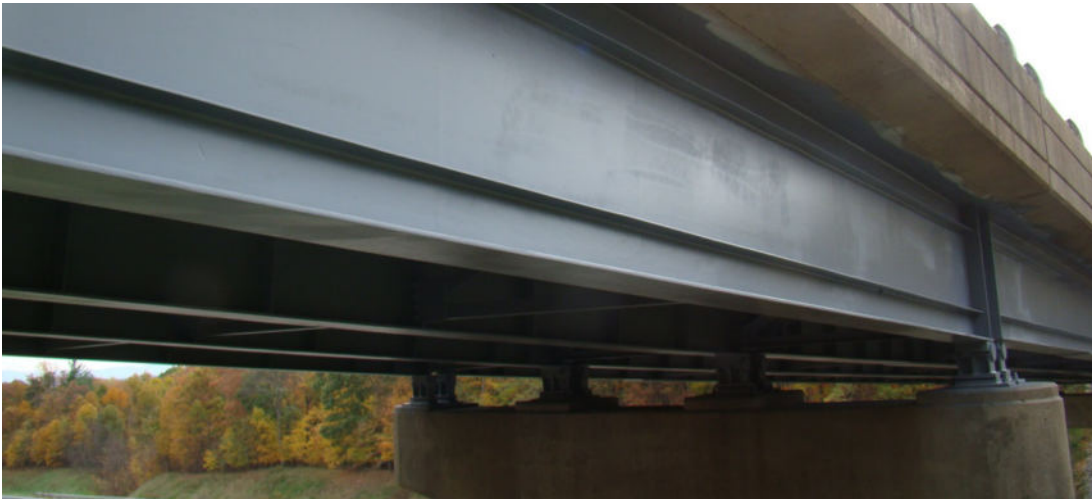
Coated Steel Beam

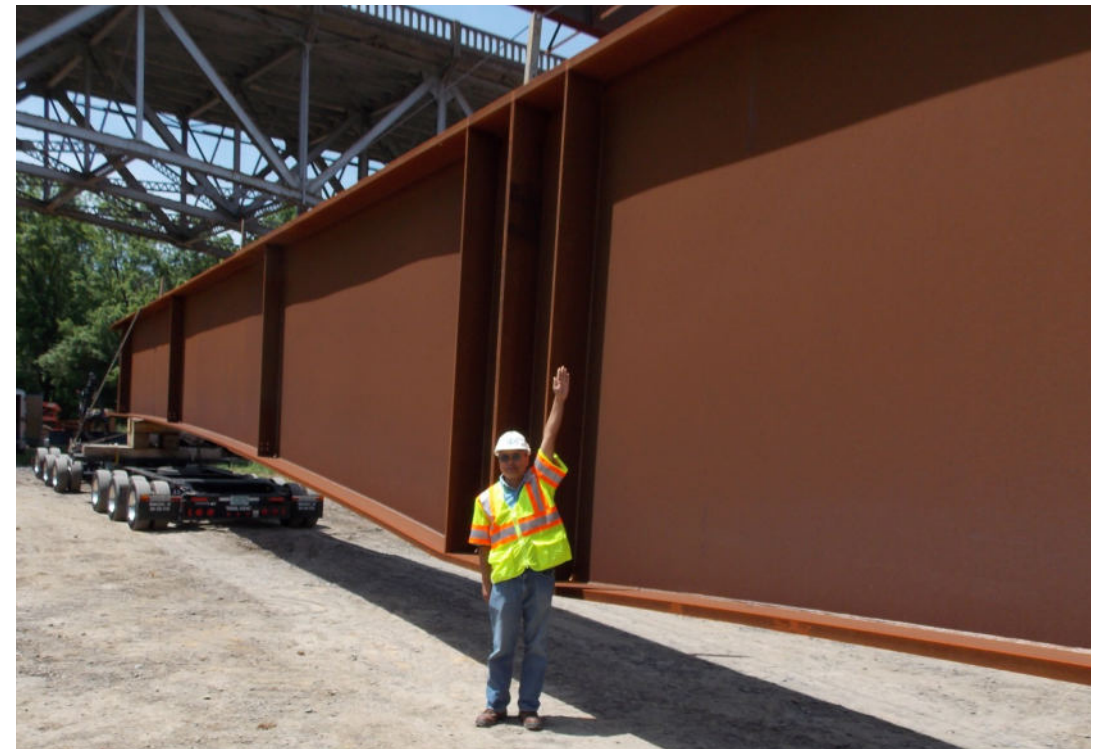
A tightly adherent protective rust “patina” acts as skin to prevent further corrosion to the steel beneath.

Weathering Steel Beam

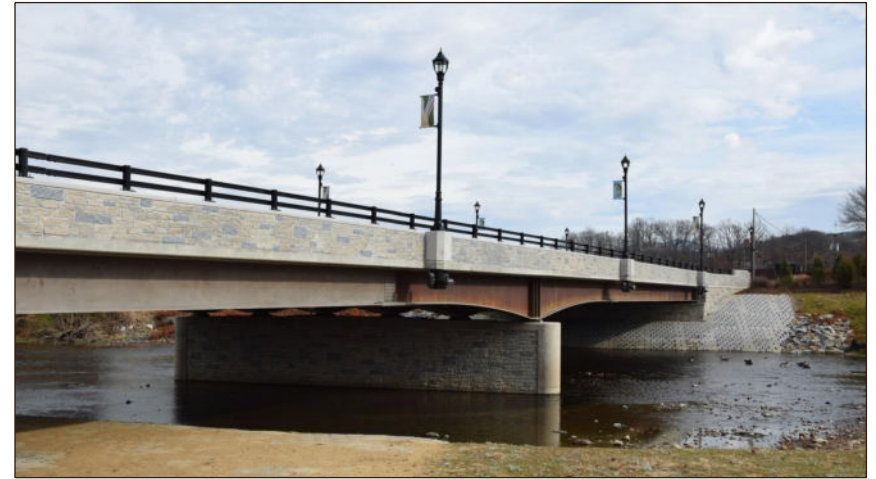
## The 1<sup>st</sup> All-Corrosion Resistant Steel Bridge in the USA

Route 340 over South River in Waynesboro

### Grade 50W

Element	Composition (%)
Carbon (C )	0.19 max
Manganese (Mn)	0.80–1.25
Phosphorus (P)	0.03 max
Sulfur (S)	0.03 max
Silicon (Si)	0.30–0.65
Nickel (Ni)	0.4 max
Chromium (Cr)	0.40–0.65

### Grade 50CR

Element	Composition (%)
Carbon (C )	0.03 max
Manganese (Mn)	1.5 max
Phosphorus (P)	0.04 max
Sulfur (S)	0.01 max
Silicon (Si)	1 max
Nickel (Ni)	1.5 max
Chromium (Cr)	10.5-12.5

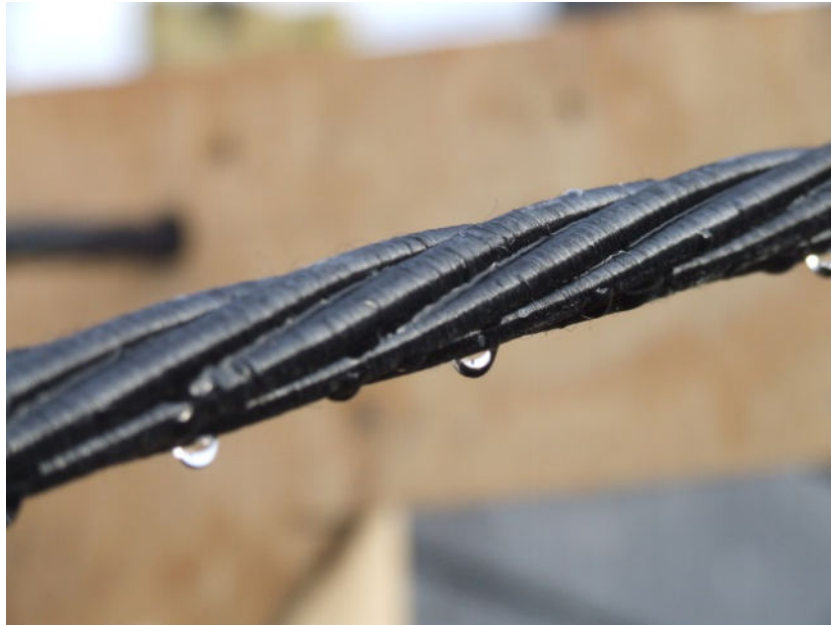
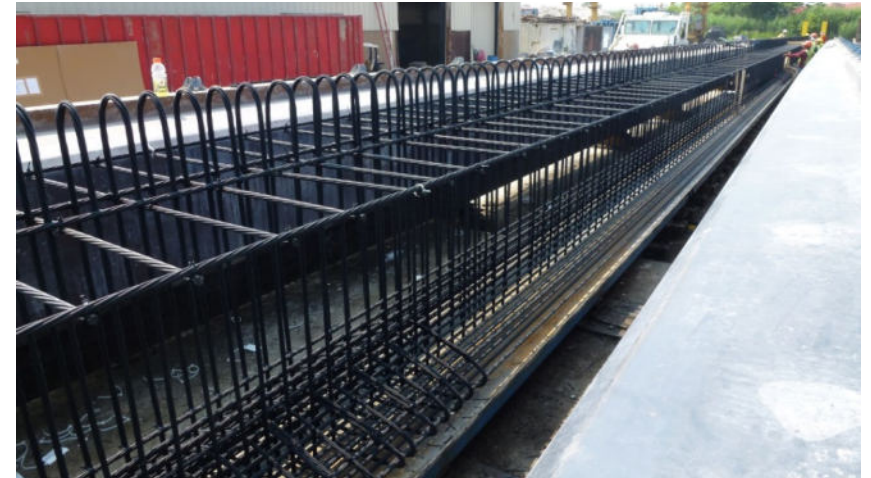
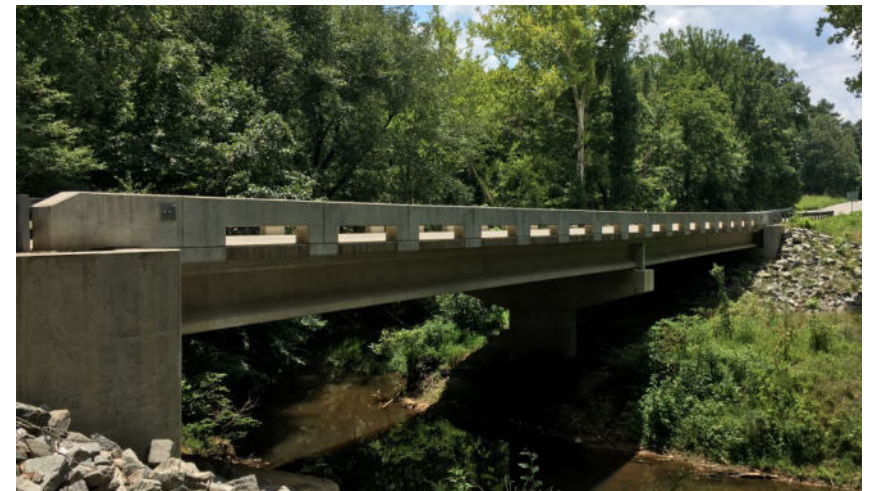
## The 1<sup>st</sup> All-CFRP Bridge in the USA

Route 49 over Aaron's Creek in Halifax County
